ENHANCED PRELIMINARY ASSESSMENT REPORT:

JEFFERSON PROVING GROUND MADISON, INDIANA

March 1990

Ebasco Environmental
5000 Bradenton Avenue
Dublin, Ohio 43017

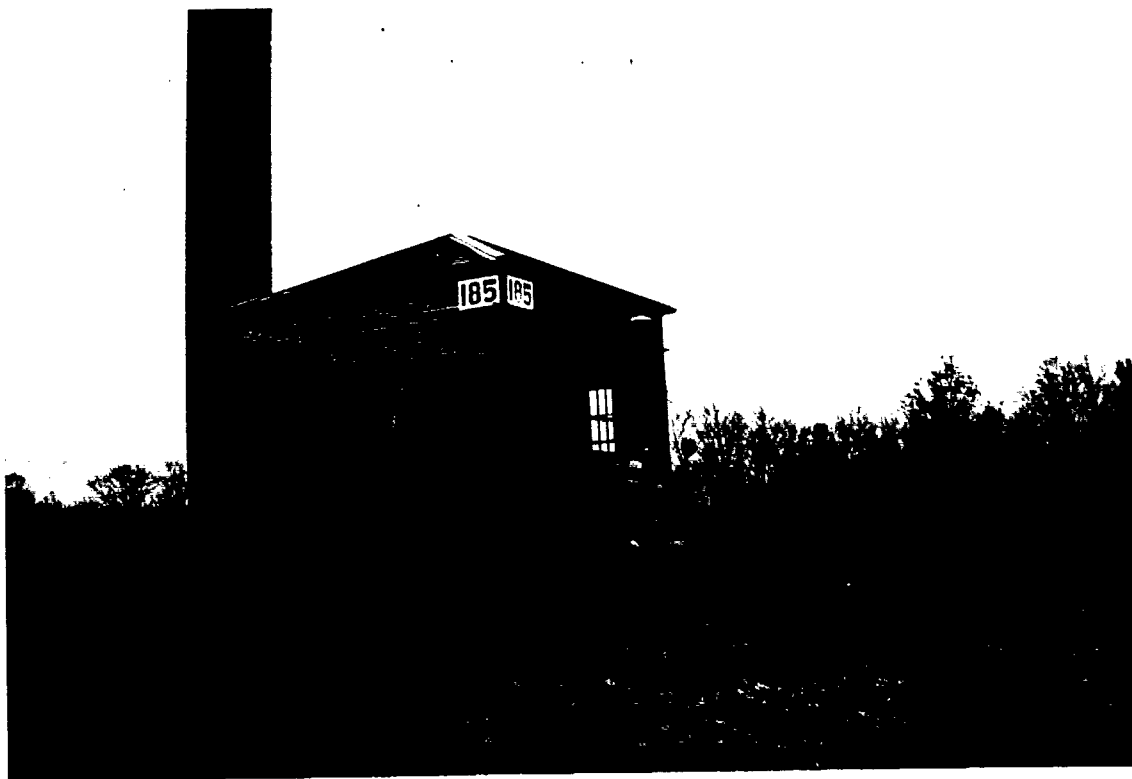
JPG-001 OLD INCINERATOR; 11/15/89

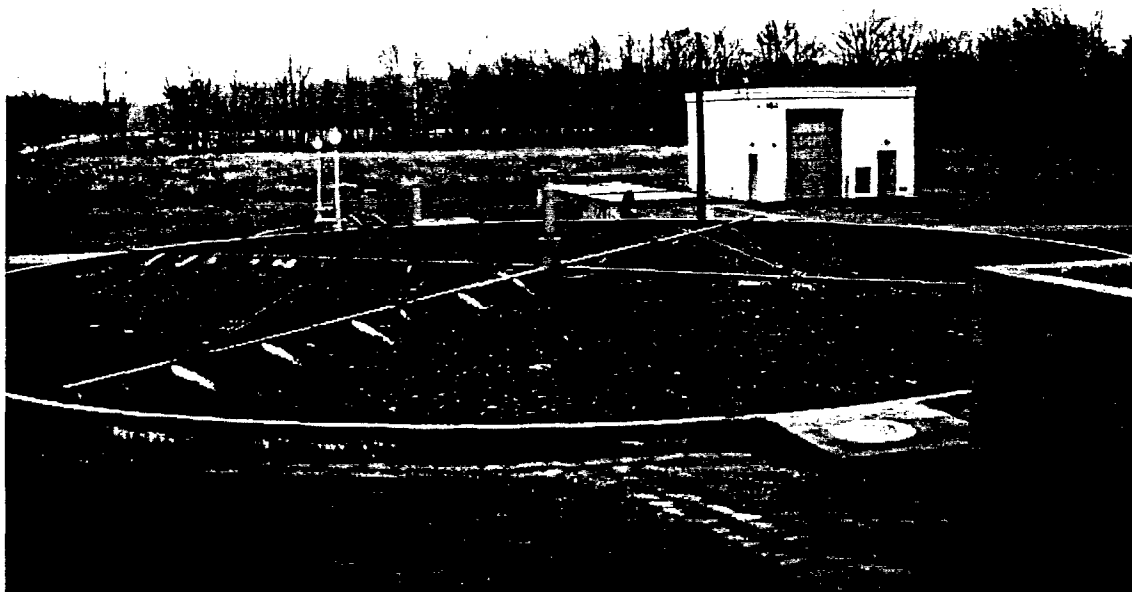
JPG-003 SEWAGE TREATMENT PLANT - Trickling Filter; 11/15/89

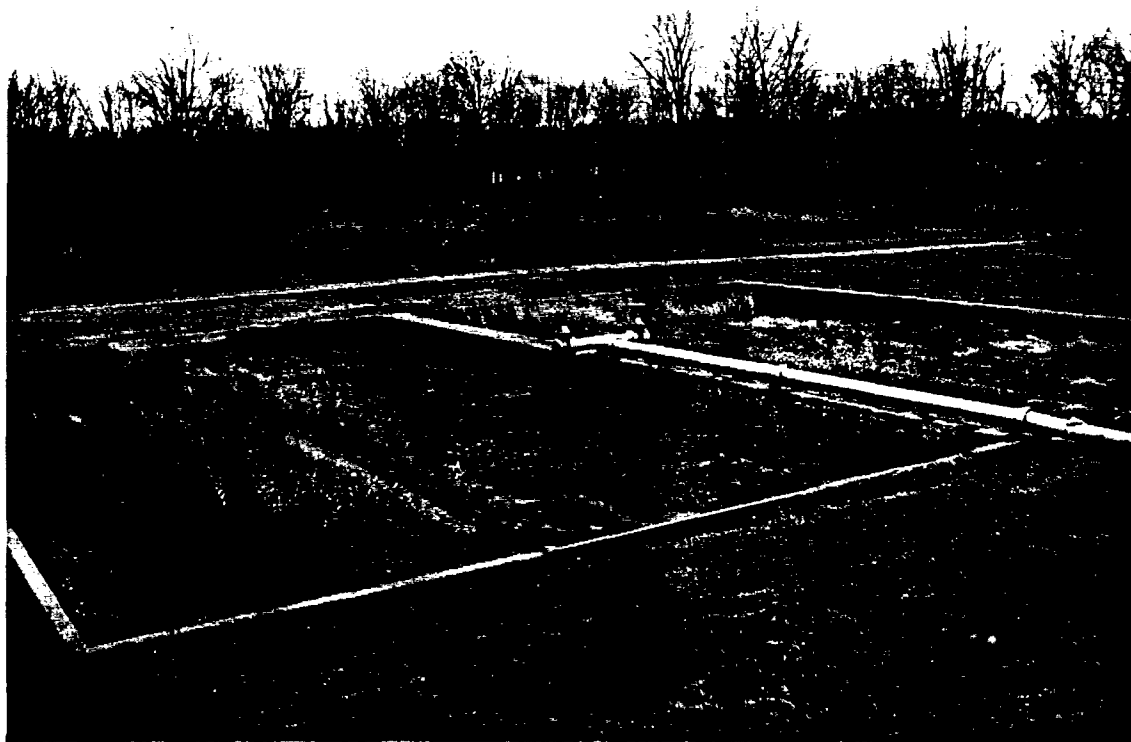
JPG-003 SEWAGE TREATMENT PLANT - Sludge Drying Beds; 11/15/89

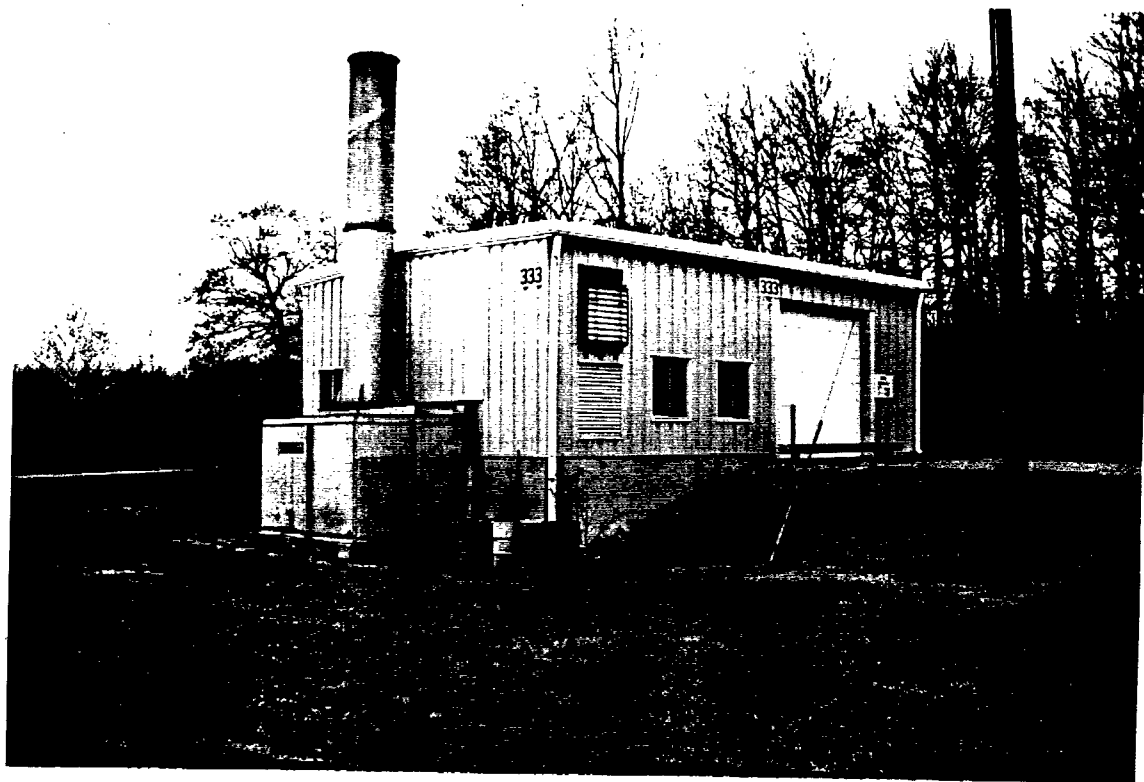
JPG-011 (BLDG. 333) NEW INCINERATOR - Drums of waste oil; 11/15/89

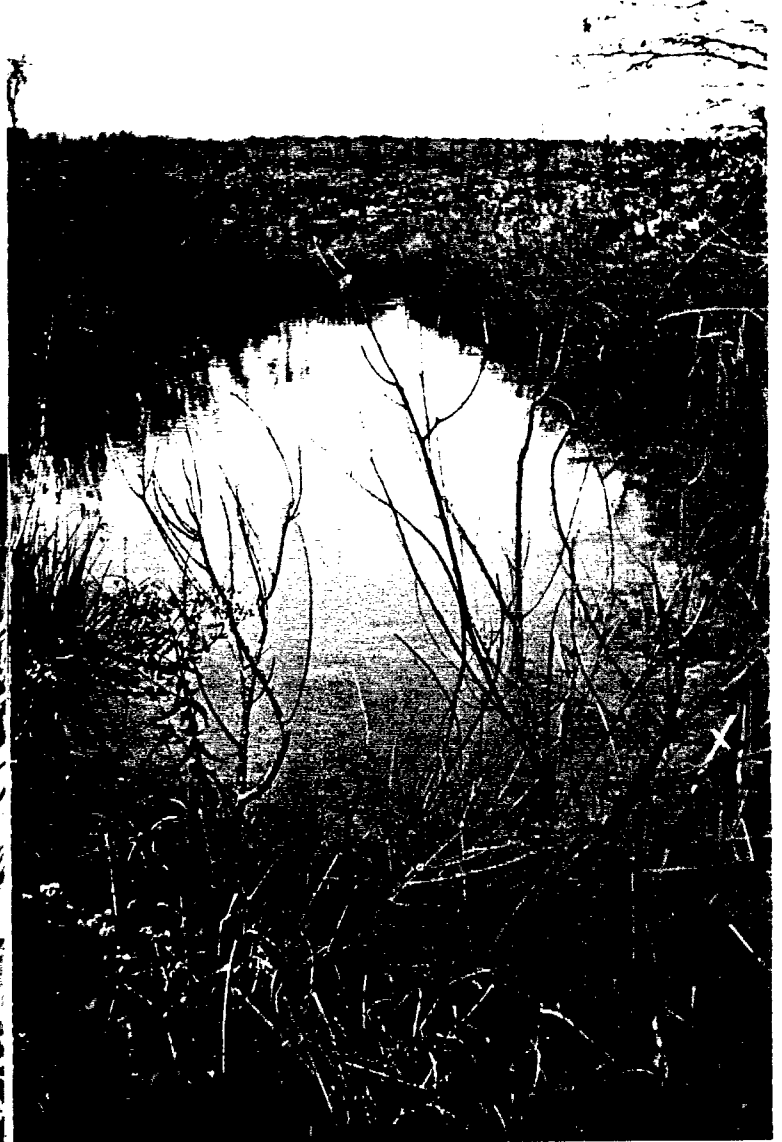
JPG-016 ORDNANCE DISPOSAL SITE - Pit filled w/water; 11/14/89

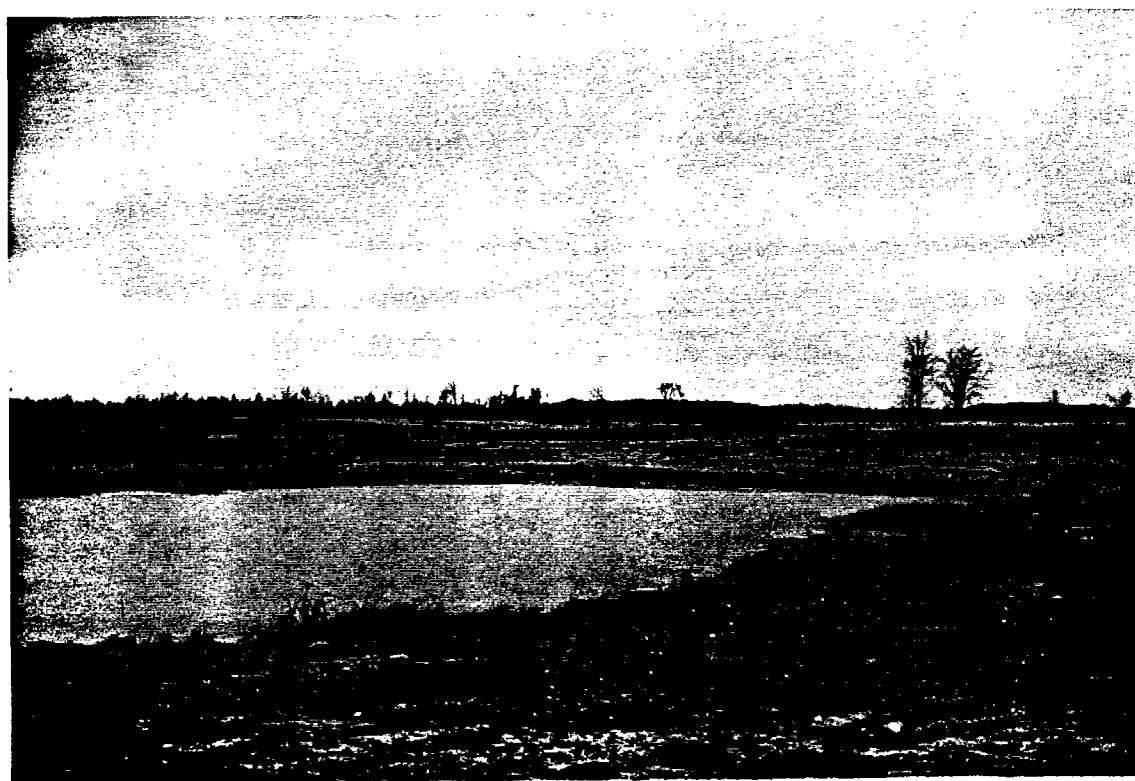
JPG-023 OPEN DETONATION AREA - sinkhole, old crater; 11/14/89

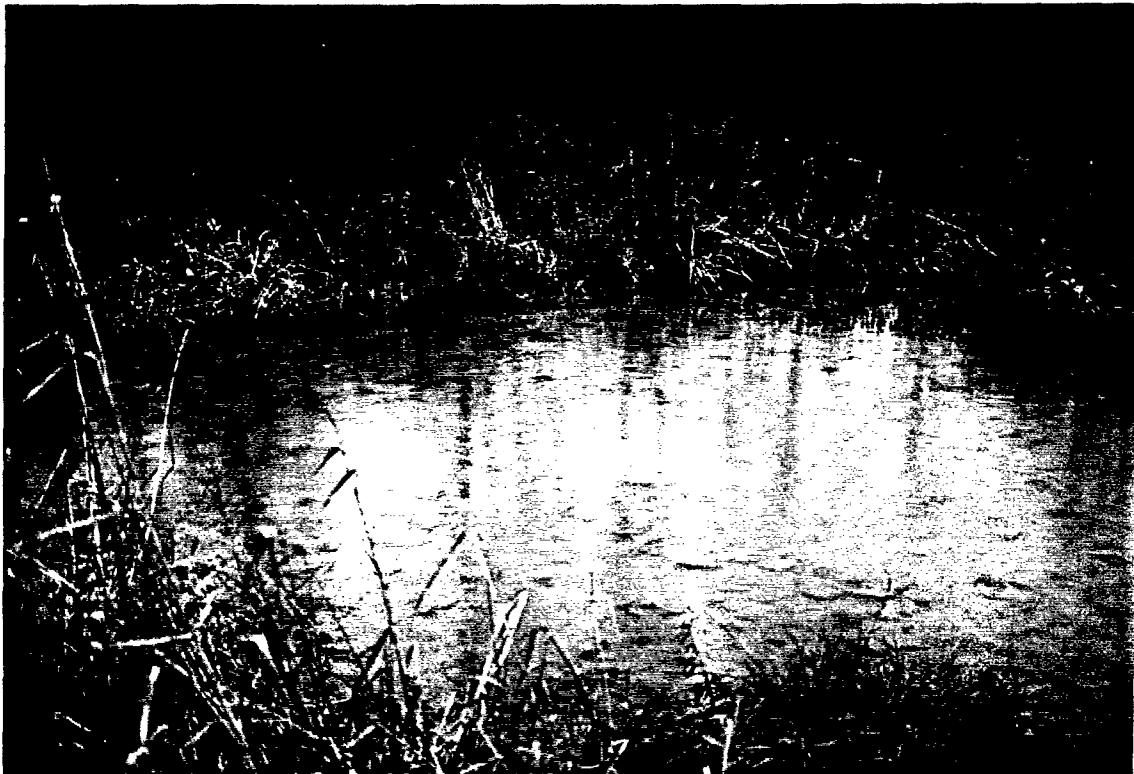
JPG-024, JPG-025 - Ponded water; 11/14/89

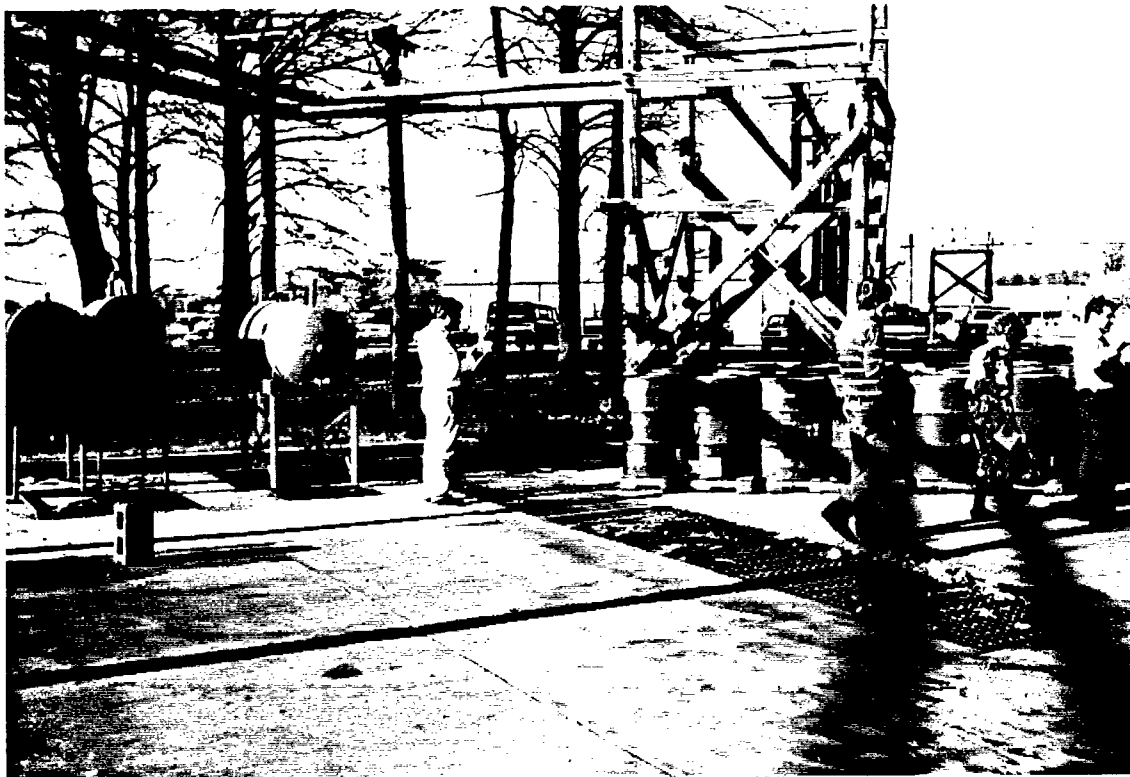
BUILDING 186 MAINTENANCE GARAGE - Oil separator pit; 11/13/89

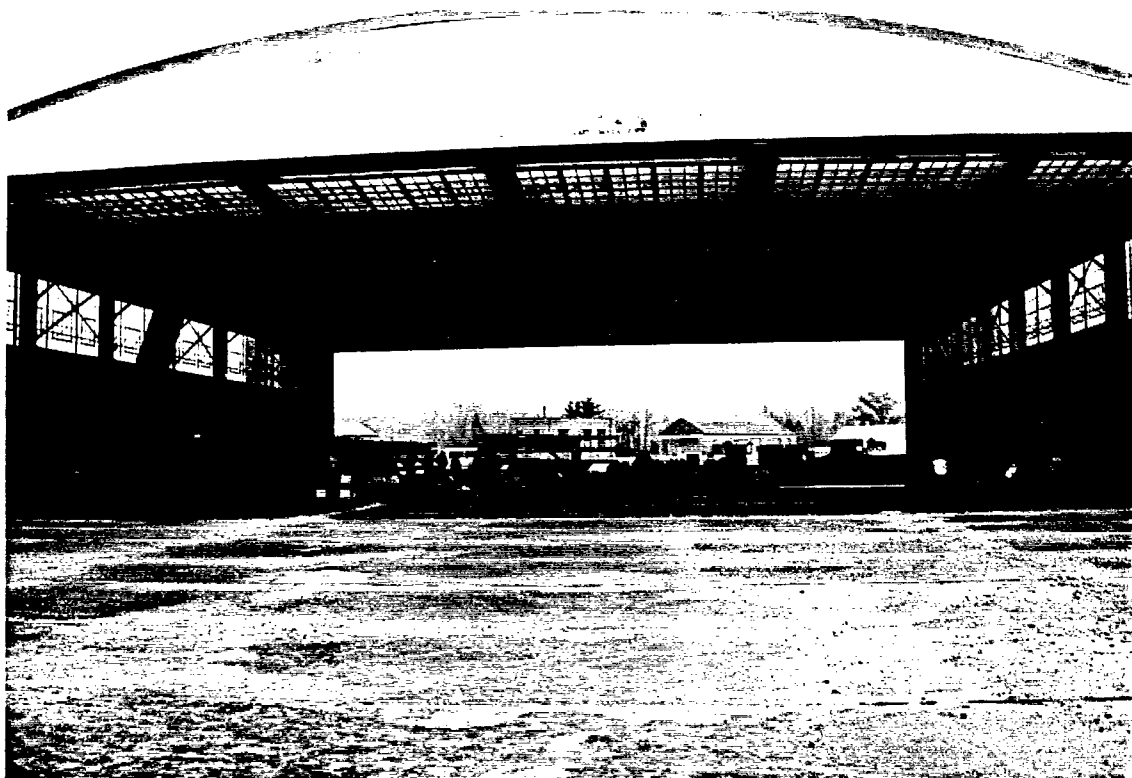
HANGAR - Asbestos pipe insulation on floor; E. wall of main area; 11/15/89

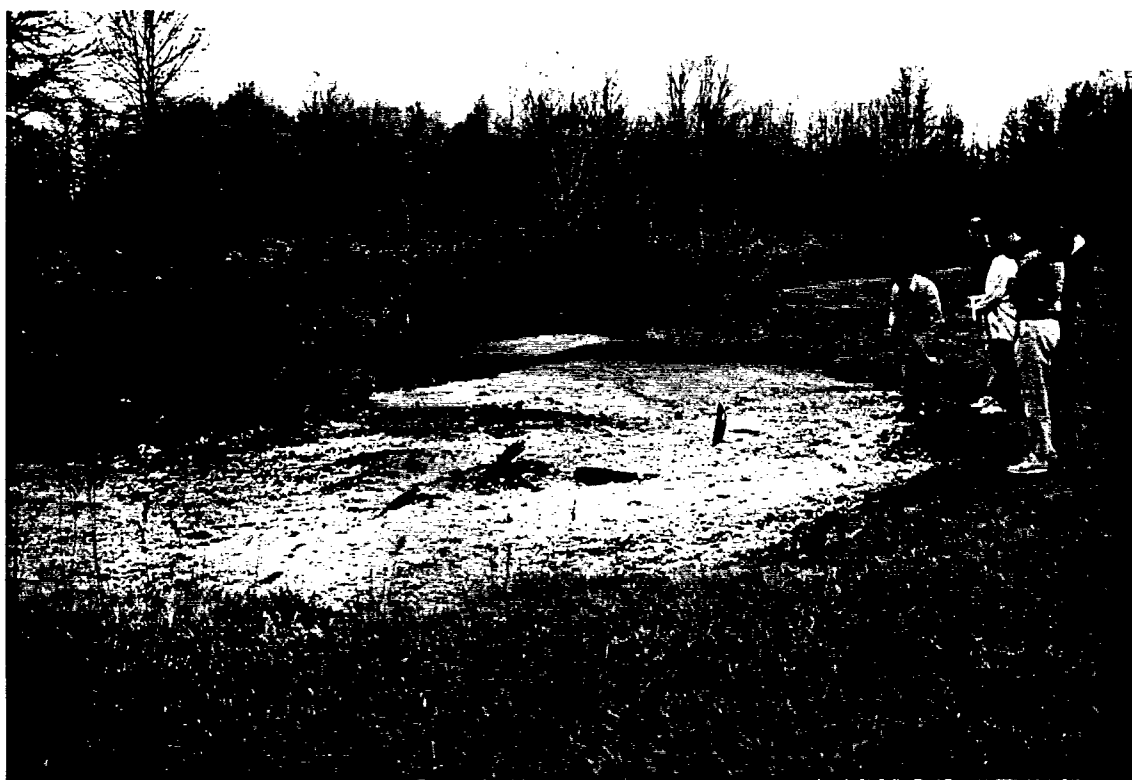
SULFUR PILE -Disposal area; 11/15/89

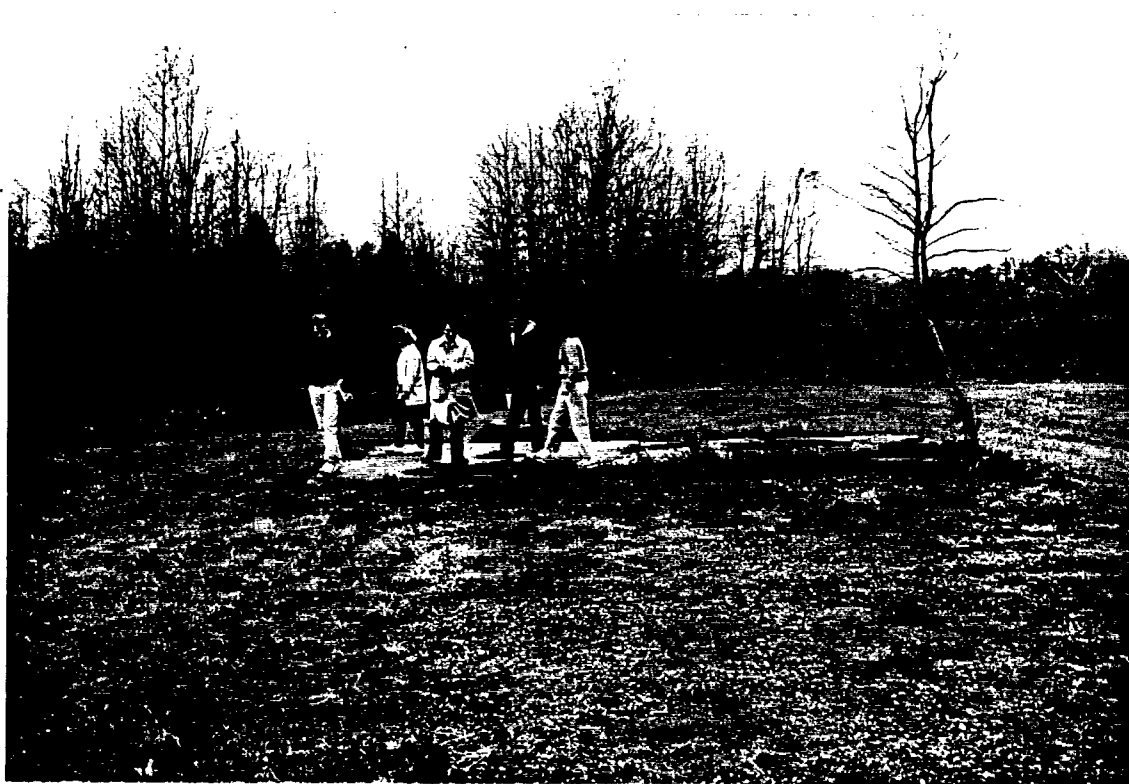
BURNED AREA - S. of the New Incinerator; 11/15/89
